Company Name: 149 County Road Management Limited

Inspector Name: Thomas Dellow AIRPM

Inspection Date: 17 January 2023

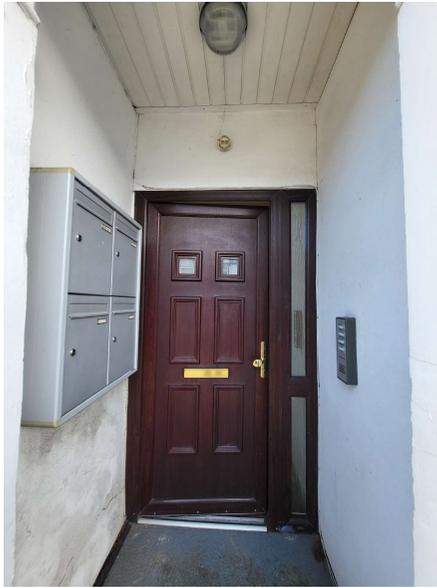
Entrances (Main Doors)

| Internal Inspection | Acceptable | Not Acceptable | N/A | Comments | Action |
|--|---|---|---|--|---|
| Entrances (Main doors) | ✓ | | | The main entrance door was secure. | None |

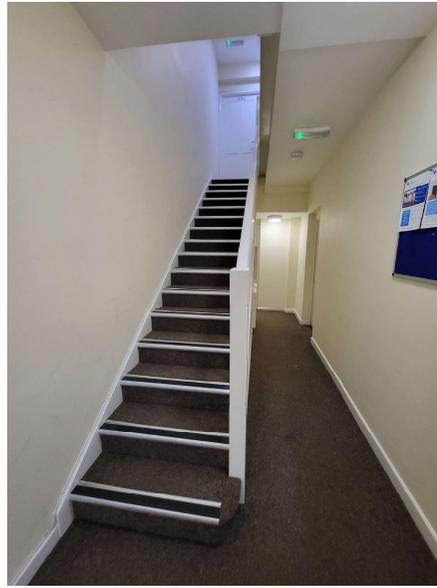
| Internal Inspection | Acceptable | Not Acceptable | N/A | Comments | Action |
|--|---|---|---|--|---|
| Hallway (Communal Lobbies and Stairs) | ✓ | | | The hallways and stairs were clear of obstruction. | None |

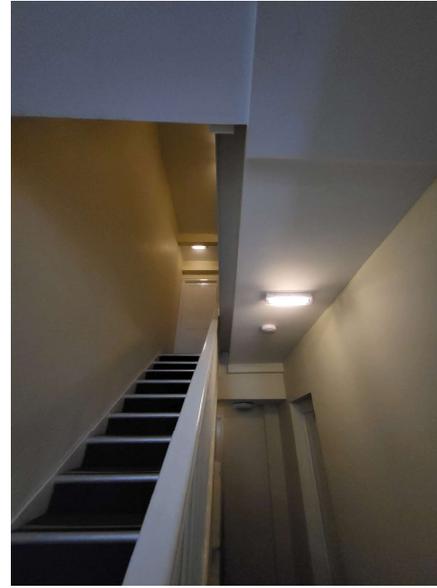
Lighting (Standard and Emergency Lights)

| Internal Inspection | Acceptable | Not Acceptable | N/A | Comments | Action |
|--|---|---|---|--|---|
| Lighting (Standard and Emergency Lighting) | ✓ | | | The lighting was in good visual condition, the emergency lighting was tested with no faults. | None |

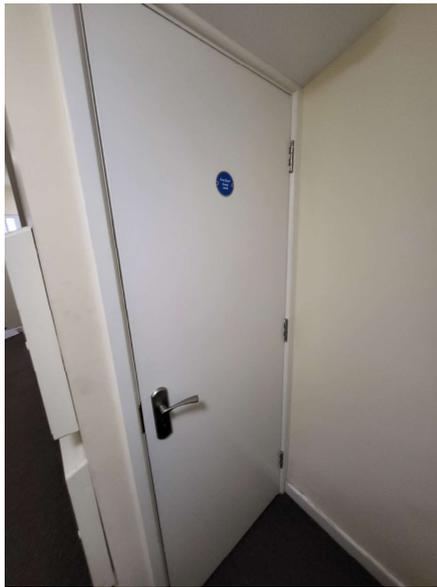
| Internal Inspection | Acceptable | Not Acceptable | N/A | Comments | Action |
|--|---|---|---|--|---|
| Cupboard Doors (Electrical Cupboard Doors) | ✓ | | | The electrical cupboard was locked and secure. | None |

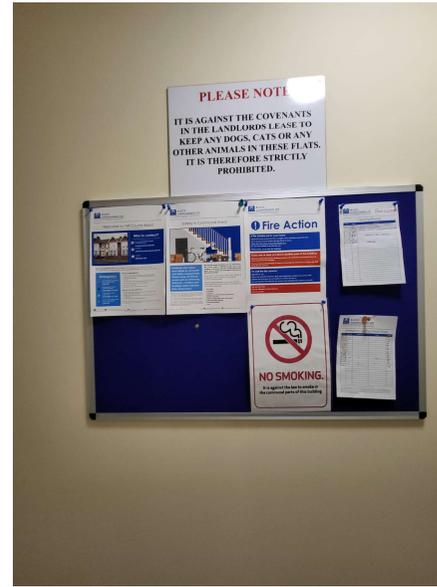
| Internal Inspection | Acceptable | Not Acceptable | N/A | Comments | Action |
|--|---|---|---|--|---|
| Signage (Communal Notices) | ✓ | | | The communal notice board was accessible. | None |

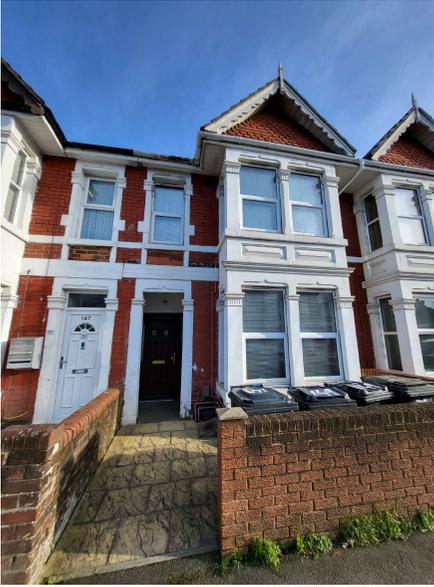
| External Inspection | Acceptable | Not Acceptable | N/A | Comments | Photos |
|---|---|---|---|---|---|
| Exterior Structure (The Building) | ✓ | | | The exterior appeared in good condition. | None |

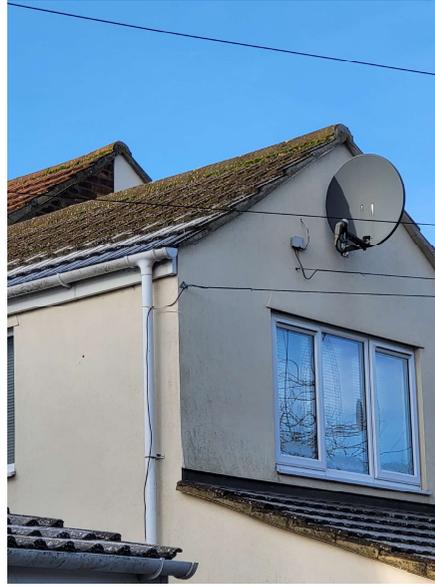
| External Inspection | Acceptable | Not Acceptable | N/A | Comments | Photos |
|---|---|---|---|---|---|
| Guttering (Gutters and Fascia) | ✓ | | | The guttering appeared in fair condition. | None |

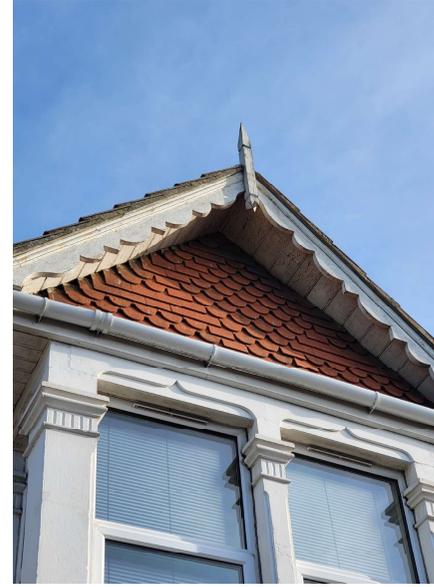
| External Inspection | Acceptable | Not Acceptable | N/A | Comments | Photos |
|---|---|---|---|---|---|
| Roofing (Tiles and Cladding) | ✓ | | | The roofing appeared in good condition. | None |

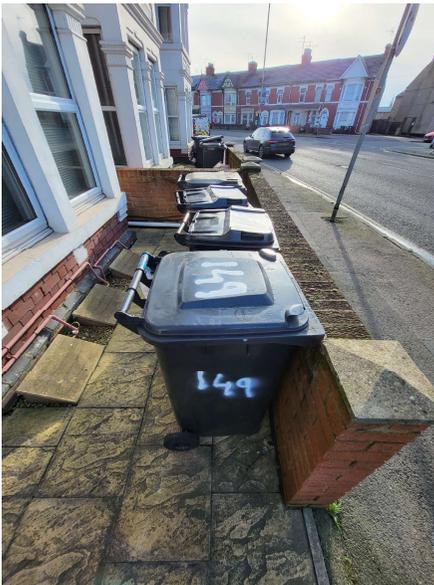
Bin Store (Waste Disposal Area)

| External Inspection | Acceptable | Not Acceptable | N/A | Comments | Photos |
|---|---|---|---|---|---|
| Bin Store (Waste Disposal Areas) | ✓ | | | The bin area was tidy. | None |
