ASBESTOS MANAGEMENT SURVEY REPORT

149 County Road, Swindon, SN1 2EB

37910-162840

Report Issue date: 13/06/2016

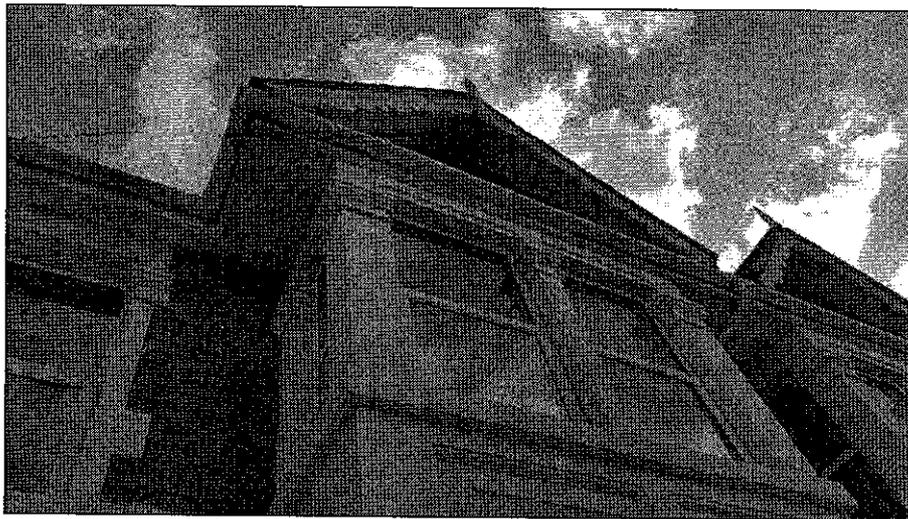
Client:	Home from Home	Area No:	External
Site Address:	149 County Road, Swindon, SN1 2EB	Floor:	First
Building:		Area Description:	External
Building Address:	149 County Road	Material Description:	Cement verge undercloaking to front elevation
		Survey Report Reference:	37910-162840-0001

Material Risk:	4
Asbestos Type:	1 - Chrysotile (Presumed)
Product Type:	1 - Asbestos composites, decorative finishes, AC
Extent of Damage:	1 - Low damage
Surface Treatment:	1 - Enclosed sprays and lagging, AIB, AC sheets etc
Priority Risk:	1
Normal Occupant Activity:	0 - Rare Disturbance
Likelihood of Disturbance:	0 - Very Low Likelihood of Disturbance
Human Exposure Potential:	1 - Low Human Exposure Potential
Maintenance Activity :	0 - Minor Risk Maintenance Activity

Sample No:	P
Position:	External
Approx Size of Item:	4 Linear m

Comments: Presumed asbestos.
Presumption Reason: height restrictions

Total Risk Score: 5

Timescale for Recommendation : 12 months

Recommendation: Manage

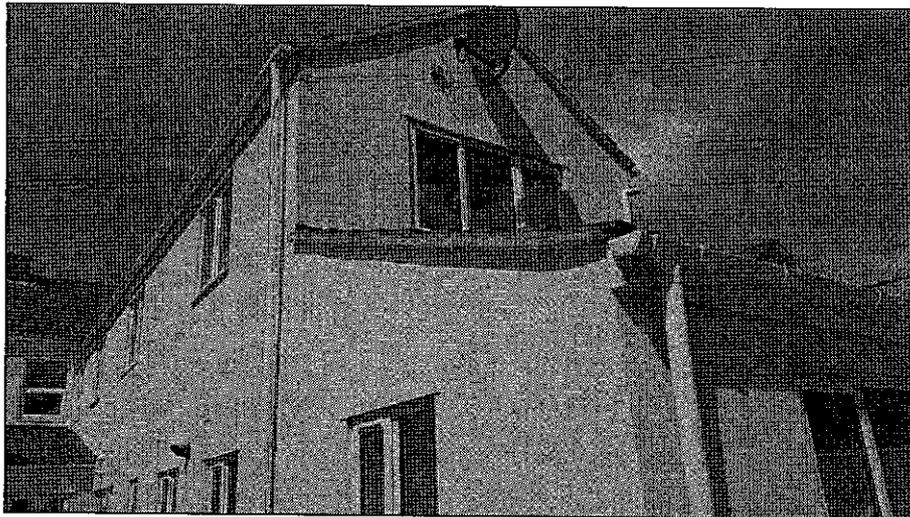
Client:	Home from Home	Area No:	External
Site Address:	149 County Road, Swindon, SN1 2EB	Floor:	Ground
Building:		Area Description:	External
		Material Description:	Cement verge undercloaking
Building Address:	149 County Road	Survey Report Reference:	37910-162840-0001

Material Risk: 0
Asbestos Type: 0 - No asbestos detected

Sample No: 001
Position: External
Approx Size of Item: 10 Linear M

Total Risk Score: 0

Timescale for Recommendation : No action

Recommendation: No further action required
