**Company Name:** 149 County Road Management Limited

**Inspector Name:** Thomas Dellow MIRPM

**Inspection Date:** 21 November 2023

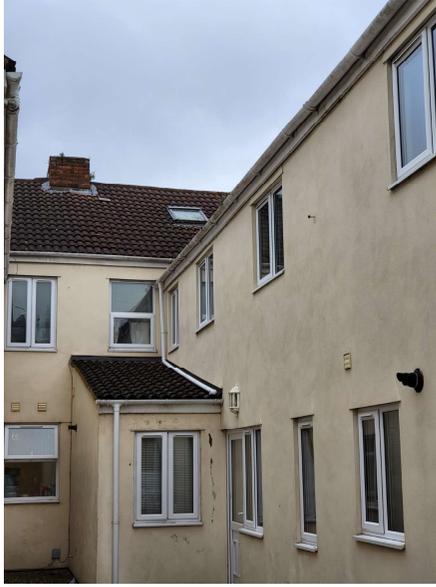
External Inspection	Acceptable	Not Acceptable	N/A	Comments	Photos
<b>Exterior Structure</b> (The Building)	✓			The exterior appeared in good condition. It is noted that there is damage to the rear wall.	Review
<b>Guttering</b> (Gutters and Fascia)	✓			The guttering appeared in fair condition.	None
<b>Roofing</b> (Tiles and Cladding)	✓			The roofing appeared in good condition.	None
<b>Communal Grounds</b> (Gardens and Common Areas)	✓			The grounds were clear of obstruction.	None
<b>Bin Store</b> (Waste Disposal Areas)	✓			The bin area was tidy.	None
<b>Car Park</b> (Vehicle Parking)	✓			The rear car park was clear of obstruction.	None
<b>Bike Store</b> (Bicycle Areas)			✓	There is no bike store.	None
<b>Additional Comments</b>					None
