# COMBINED FIRE AND HEALTH & SAFETY RISK ASSESSMENT.

| Address of premises: | 149 County Road<br>Swindon<br>SN1 2EB |
| Date of fire risk assessment: | 3 <sup>rd</sup> November 2025 |

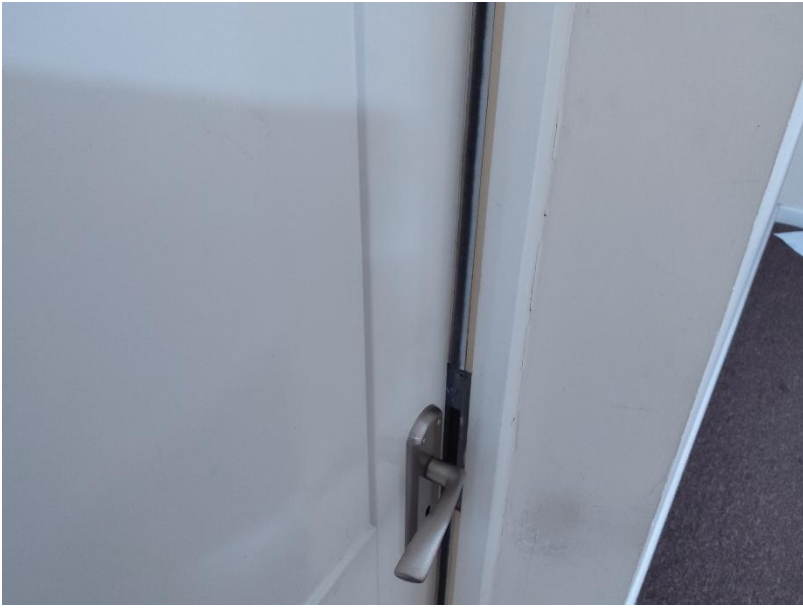
| Item | Recommendation | Priority | Timescale |
|---|---|---|---|
| 01 | <p>A type 1 fire risk assessment requires us to conduct a fire door survey on a sample of flat front doors. The door to flat 149B was surveyed during this sample in which the following deficiencies were found:</p> <ul style="list-style-type: none"> <li>No fire rated hinges</li> <li>Did not fully self-close</li> </ul> <p>It is essential that each flat entrance door is a suitable fire door, providing a minimum of thirty minutes fire resistance, hung on three grade 13 hinges and having a functioning self-closing device fitted that positively closes the door on the latch, together with smoke and intumescent seals. It is recommended therefore that the RP instruct a suitably qualified and competent contractor to conduct a fire door inspection to all flat entrance doors providing advice on suitability as per "Fire Resisting Doors – 62-12 to 62.17" of Fire Safety in Purpose-Built Block of Flats. Any shortcomings identified by this inspection should be addressed as a priority by upgrading or replacing the door.</p> <p>Flat entrance doors, communal area doors, the seals and the self-closing devices should then be subjected to an annual inspection and maintenance schedule.</p> | 2 | B |

Action required  
DH has informed leaseholder.

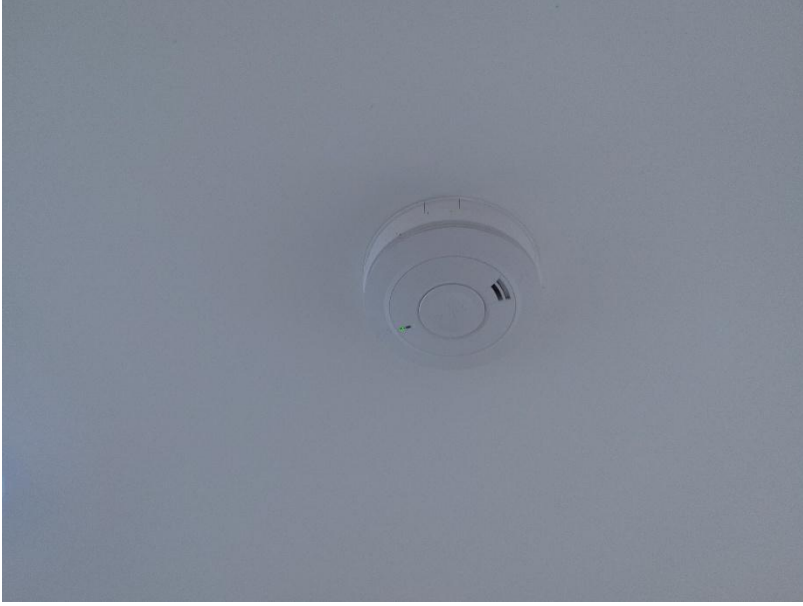
| 02 | <p>There are hardwired smoke detectors installed within the common areas.</p> <p>It is recommended that this system be upgraded to a mixed grade fire detection system, comprising of a BS5839-6: 2019 Grade D fire detection system, providing LD3 coverage, comprising of hard-wired smoke detectors, each with battery back up on each floor level of the communal areas and hard-wired heat detectors within the lobby of each flat, again, each with battery back up.</p> <p>Additionally, a separate, interconnected system of hard-wired smoke detectors should be installed within the escape route (lobby) of each flat, together with each room that communicates with the escape route and a heat detector within each flat kitchen. These should be interlinked within each flat to provide a BS5839-6: 2019 Grade D detection system with LD2 coverage in order to protect sleeping occupants of individual flats.</p> <p>This would be a suitable fire detection system for this converted property and complies with the recommendations contained within LACORS.</p> | 2 | B | <p>Action required</p> <p>RP to consider upgrades.</p> |

| <p>There are hardwired smoke detectors installed within the common areas.</p> <p>It is recommended that this system be upgraded to a mixed grade fire detection system, comprising of a BS5839-6: 2019 Grade D fire detection system, providing LD3 coverage, comprising of hard-wired smoke detectors, each with battery back up on each floor level of the communal areas and hard-wired heat detectors within the lobby of each flat, again, each with battery back up.</p> <p>Additionally, a separate, interconnected system of hard-wired smoke detectors should be installed within the escape route (lobby) of each flat, together with each room that communicates with the escape route and a heat detector within each flat kitchen. These should be interlinked within each flat to provide a BS5839-6: 2019 Grade D detection system with LD2 coverage in order to protect sleeping occupants of individual flats.</p> <p>This would be a suitable fire detection system for this converted property and complies with the recommendations contained within LACORS.</p> | | |
